# Tonkin+Taylor

Tonkin + Taylor Ltd (T+T) was engaged by WFH Properties Ltd to monitor and provide earthworks certification for the 48 No. Residential Lots contained within Stage 1 of Arrans Hill Precinct 5 at the Millwater Subdivision in Silverdale. Stage 1 comprises Residential Lots 1 to 36 and 143 to 154, Wetland Reserve Lot 804, Joint Owned Access Lane Lot 600, and Road Lot 900 (parts of Roads 1, 2, 3, and 4 within Stage 1) inclusive as shown on the Woods Final Contour As–Built Plans (Woods Ref 37501–01–100–AB to 102–AB) in Appendix A1.

This Geotechnical Completion Report contains information required for subdivisional earthworks completion reporting, as well as outlining geotechnical design issues that need to be considered for subsequent building design and construction on each residential Lot.

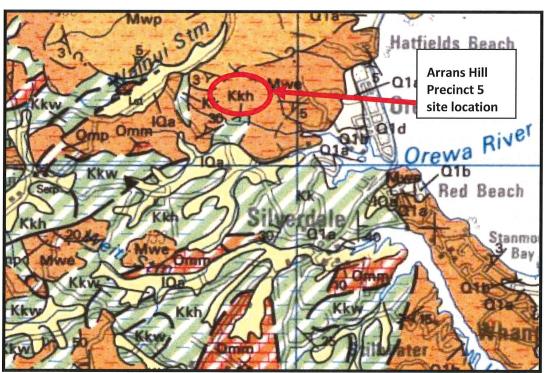
Figure 1 - Local Geology (from Edbrooke)

Published geological mapping and information indicates the Arrans Hill Precinct 5 area is underlain by East Coast Bays Formation (ECBF) materials. In addition to the ECBF materials, our investigations identified the presence of alluvial and colluvial materials on site along the stream margins.

Alluvium and Colluvium are generally observed on the lower slopes, along the edges of the tidal tributaries of the Orewa River - along the southern and eastern boundary of the site. In places, it is locally discontinuous or absent.
